6542 Sample Lane, Seattle, WA 98370

This report is prepared exclusively for **Sample 1960's Report** Inspected On: **2023-11-07**

Company Information
Orca Inspection Services LLC
206-713-5715

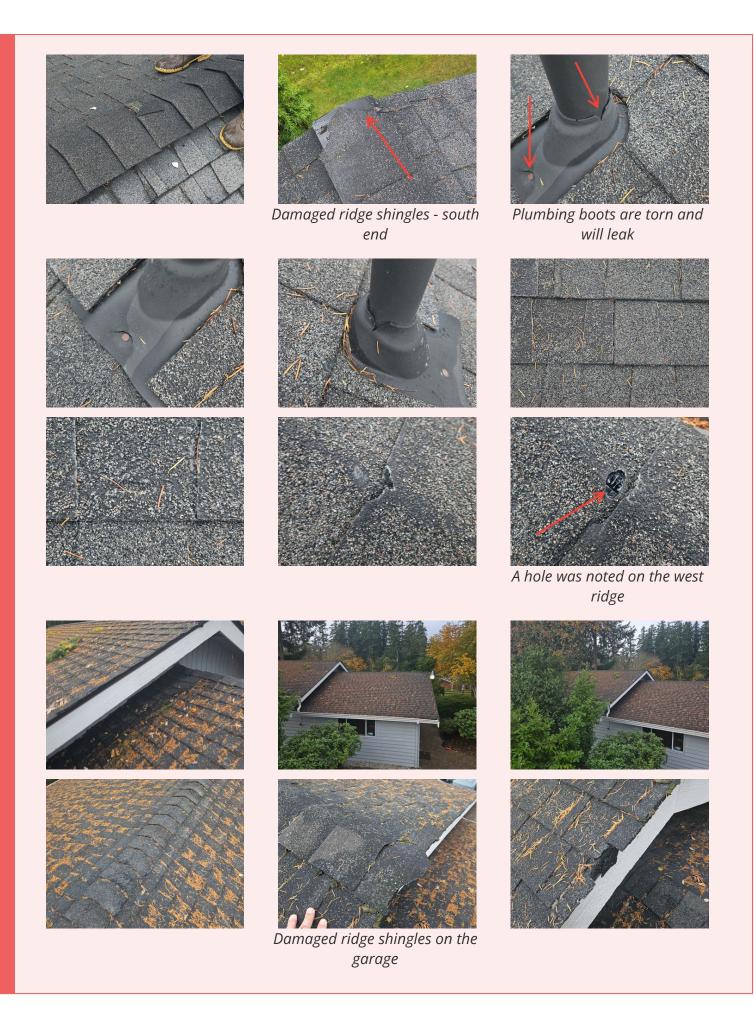
Fairly heavy granule loss noted on the roofing shingles

The roofing shingles do not adequately overhang the fascia at rake ends. These should hang off at least 1 inch.

Hire a qualified roofing contractor to further evaluate this roof and repair or replace as

recommended. Examples of specific observations noted during the inspection include:

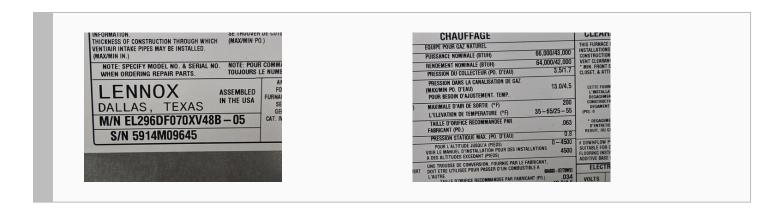
Data Plate: 🛍

This shows the data plate from the furnace.

Listed Max Capacity Per Data Plate: 66,000 btu's

Age: 2014
